Manhole Inspection Summary

Manhole # S33KK1026MH

Location Address: **4200 GREENWAY**

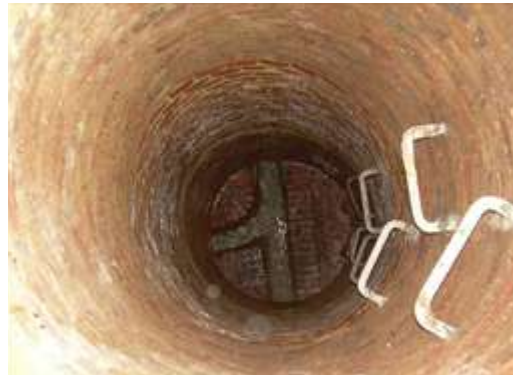
Top View

Corroded steps. Bench debris.

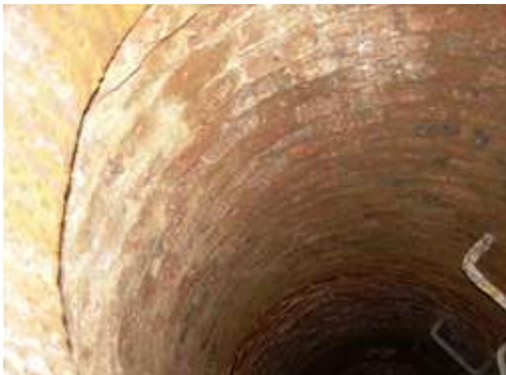
Defect

Frame leaks. Adjustment and Barrel infiltration.

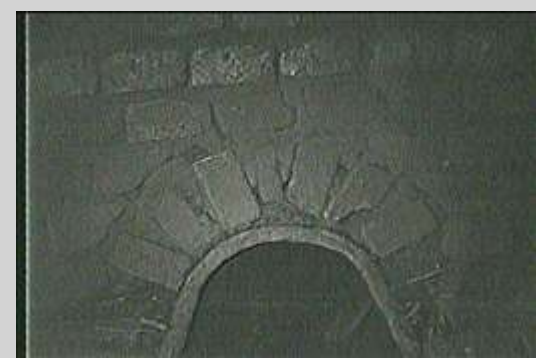
10 in. Circular Gravity Sewer Pipe Out @ 12 O'Clock

Infiltration: **Evidence** Pipe Seal Cond: **Unknown**

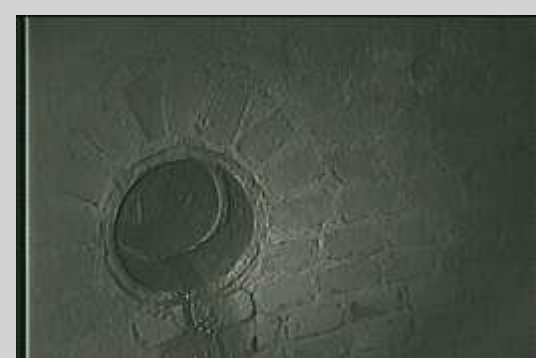
8 in. Circular Gravity Sewer Pipe In @ 6 O'Clock

Infiltration: **Evidence** Pipe Seal Cond: **Unknown**

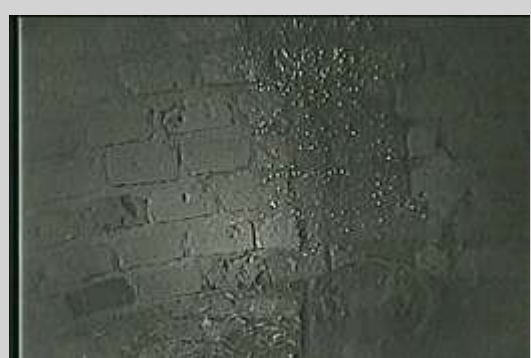
Drop In @ 6 O'Clock

Drop Condition: **Partly Clogged**

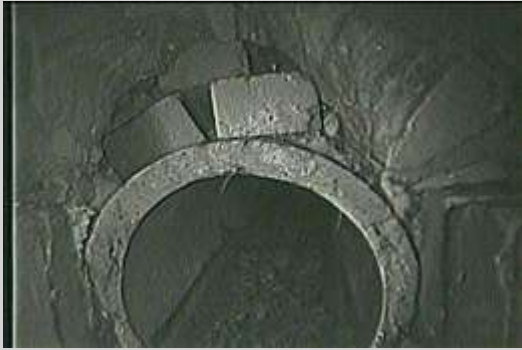
Pipe In @ 9 O'Clock

Barrel deterioration and infiltration.

Infiltration: **Evidence** Pipe Seal Cond: **Broken**
